## VEGETATION MANAGEMENT: STONY CREEK CORRIDOR BEFORE & AFTER

Clearing the Transmission corridors for safety and reliability, while restoring plant diversity and natural wildlife habitats.

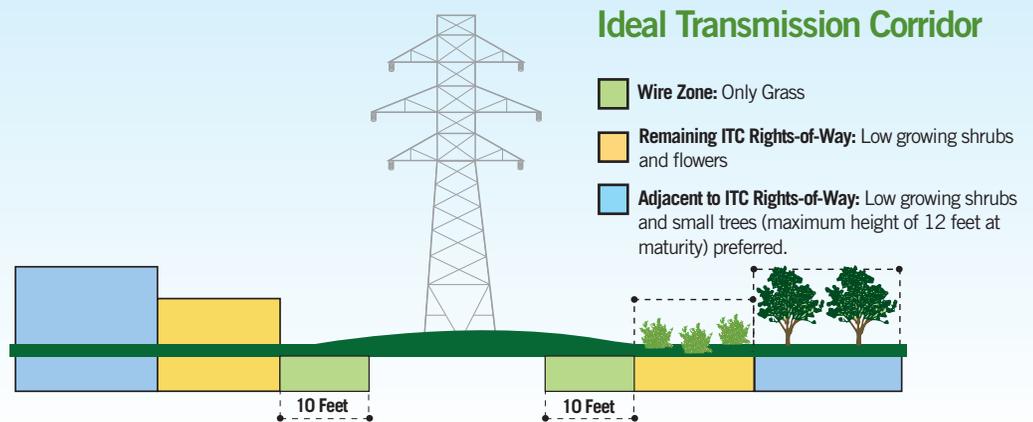
**Within the Wire Zone:** Trees growing within the wire zone (the area under and 10 feet outside the wires) shall be targeted for removal with priority emphasis given to incompatible, tall-growing species. Where we lack removal rights in the wire zone or permission is not obtained, trees shall be pruned to the maximum allowable height directing growth laterally away from wires.

**Outside the Wire Zone, but within remaining ITC Rights-of-Way:** Trees growing outside the wire zone, but within the remaining ITC Rights-of-Way will be targeted for removal, where necessary, to maintain safety and reliability, with priority emphasis given to incompatible, tall-growing species. Where we lack tree removal rights within the Rights-of-Way, or where permission is not obtained, trees shall be pruned to the maximum allowable height.

**Adjacent to ITC Rights-of-Way:** Trees growing outside and adjacent to ITC Rights-of-Way and posing a safety or reliability threat, will be pruned to the edge of our Rights-of-Way. Permission will be sought from the affected property owner to remove or prune the tree outside of the ITC Rights-of-Way.

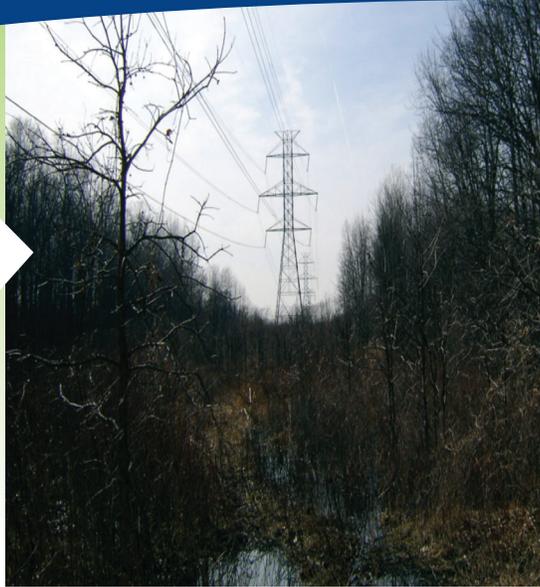
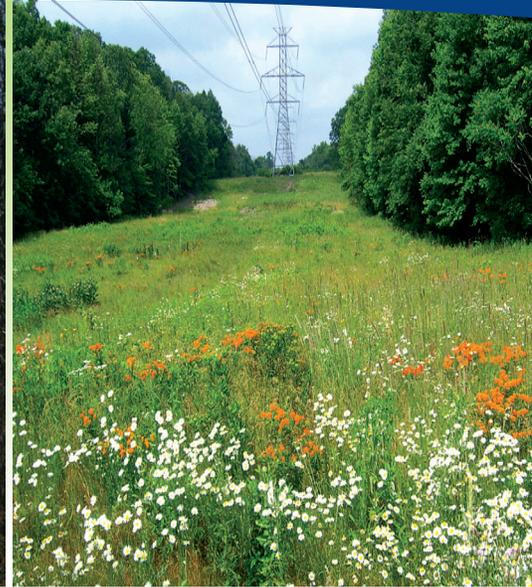
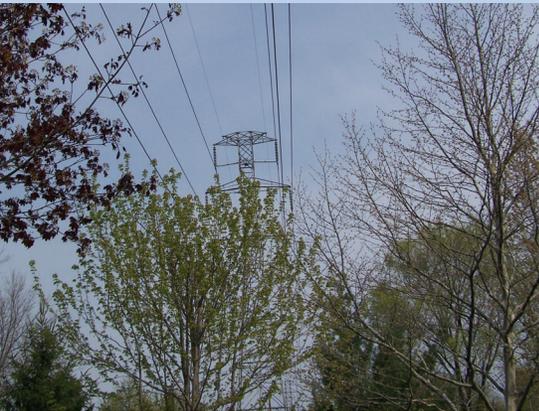
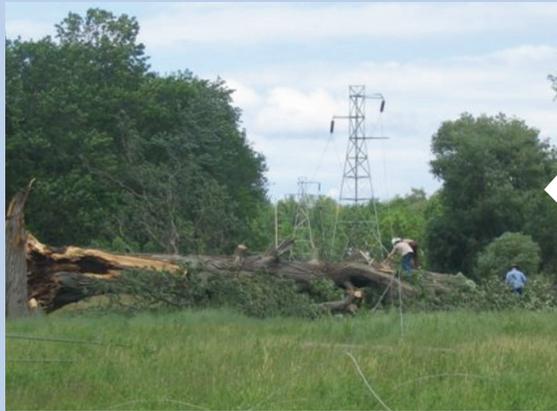
Overgrown vegetation in and near the wire zone poses a threat to the reliability and safety of the system and communities. Trees can grow into lines or eventually fall into the lines which can cause massive outages.

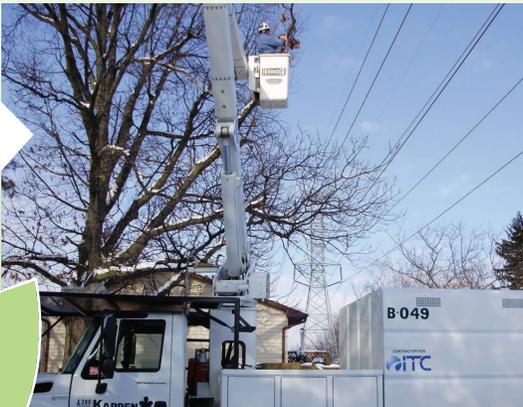
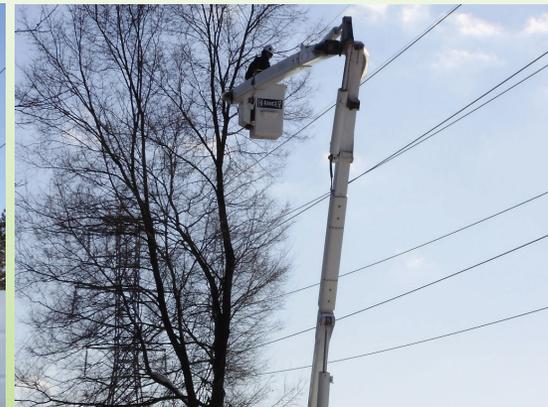
THE RESPONSE:  
Crews remove vegetation from the  
transmission wire zone
